## Tanker Industry Today

The modern tanker industry has undergone many changes in the past 50 years. These conscientious and continuous improvements have moved the industry towards safer and more responsible technologies. The following is a summary description of the major modernization milestones:

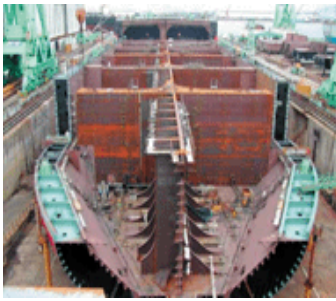
Since 1990, the United States and International regulations have required all new ships to be designed with a double hull. A double hull is essentially a hull within a hull. The cargo is carried inside the inner hull. The space between the inner and outer hull varies by ship size from 7 to 10 feet or more. If an accident should occur (i.e., grounding, stranding, collision or striking a submerged object), the space between the hulls can absorb the energy of the accident and assist in preventing petroleum from entering the water. No cargo can be loaded in the space between the hulls.
