IMO Guidelines on Annual Testing of 406MHz satellite EPIRBs for compliance with SOLAS Regulation IV/15.9

In accordance with IMO MSC/Circ.1040 (reproduced on Page 4)

McMurdo E3 & G4 Pains Wessex Rescue & Precision Sailor Satellite 406 & GPS 406

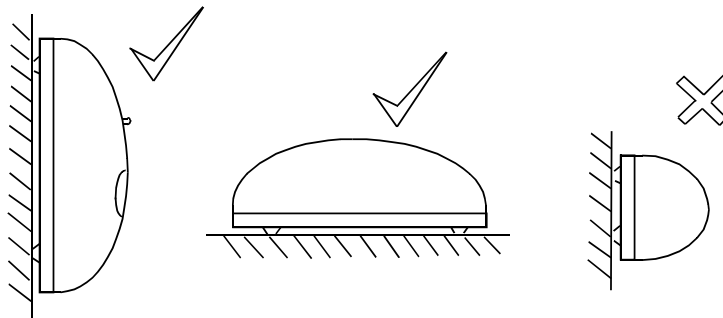
Section 3.1 Checking positioning and mounting for float-free operation

The enclosure should be mounted upright against a vertical bulkhead or horizontally on a flat surface, such as a cabin roof. No other orientations are recommended; an expanse of flat surface is required to allow the enclosure lid to eject. The released EPIRB **must not get trapped by overhangs, rigging, antennas** etc, should the vessel ever sink.

- Mount on the outside of the vessel's structure, as high as possible.
- Mount close to the vessel's navigation position.
- Consider ease of access in an emergency.

- Positions with insufficient space for lid ejection and maintenance.
- Positions within 1m (3') of any compass equipment or within 2m (6') of any Radar antenna.
- Siting where damage is likely eg direct impact from waves
- Exhaust fumes, chemical and oil sources.

- 3 The examination of the installed 406 MHz satellite EPIRB should include:
 - .1 checking position and mounting for float-free operation;
 - .2 verifying the presence of a firmly attached lanyard in good condition; the lanyard should be neatly stowed, and must not be tied to the vessel or the mounting bracket;

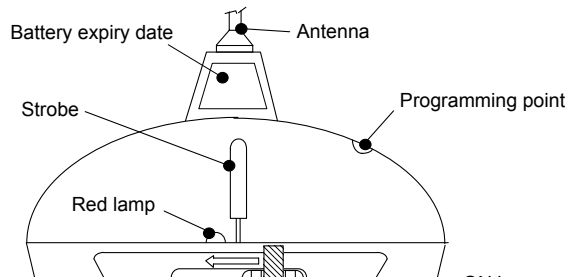
Section 3.8 Battery expiry date

The battery expiry date is also shown on the automatic release housing, where this is fitted.
